**SRN6** hovercraft

**SR.N6 HOVERCRAFT  
COLD WEATHER TRIALS IN SWEDEN  
17TH FEBRUARY TO 26TH MARCH, 1966.**

Publication SP.1294      April 1966

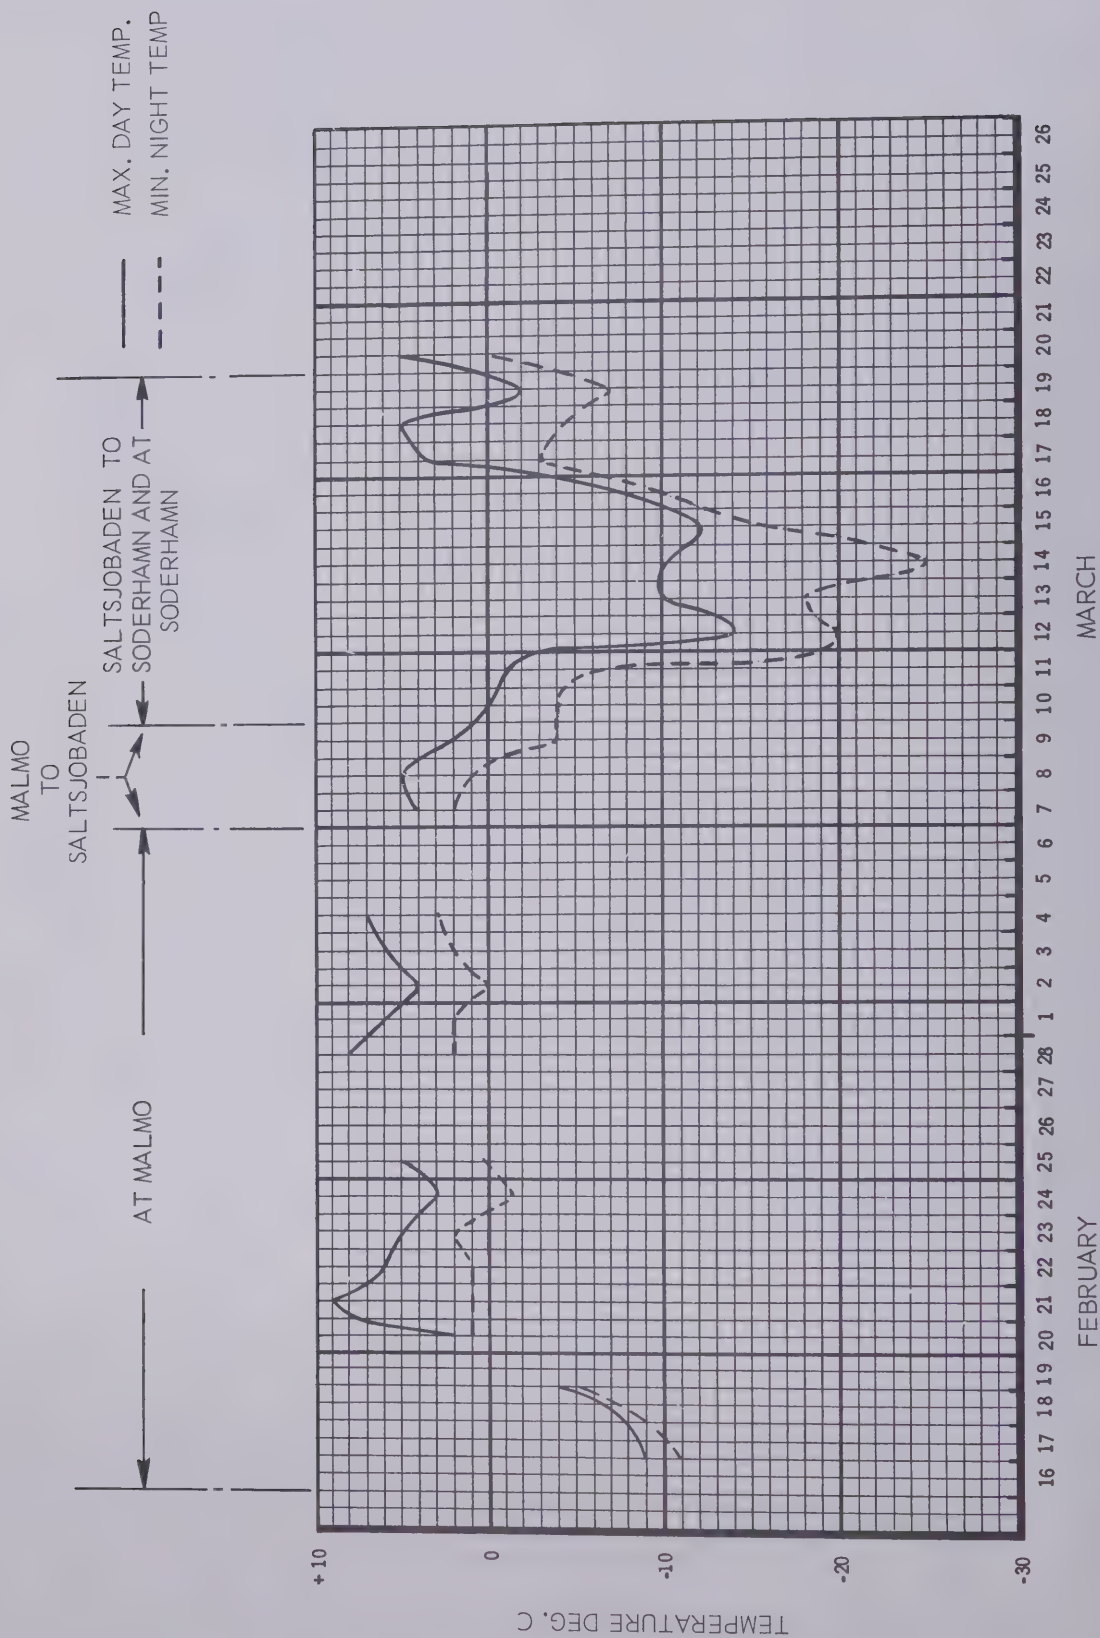
Fig. 2 DAILY RECORD OF TEMPERATURES

Day and night temperatures in the area were well below zero and had been for a considerable period. Generally the whole town and surrounding district was under 3 to 3½ feet of snow. Day temperatures averaged -10°C and night -20°C. See fig.2. It was planned therefore to investigate: (1) engine air intake from the plenum of the craft, (2) build-up of snow in rear skirts and (3) the effect of several simple de-icing systems.

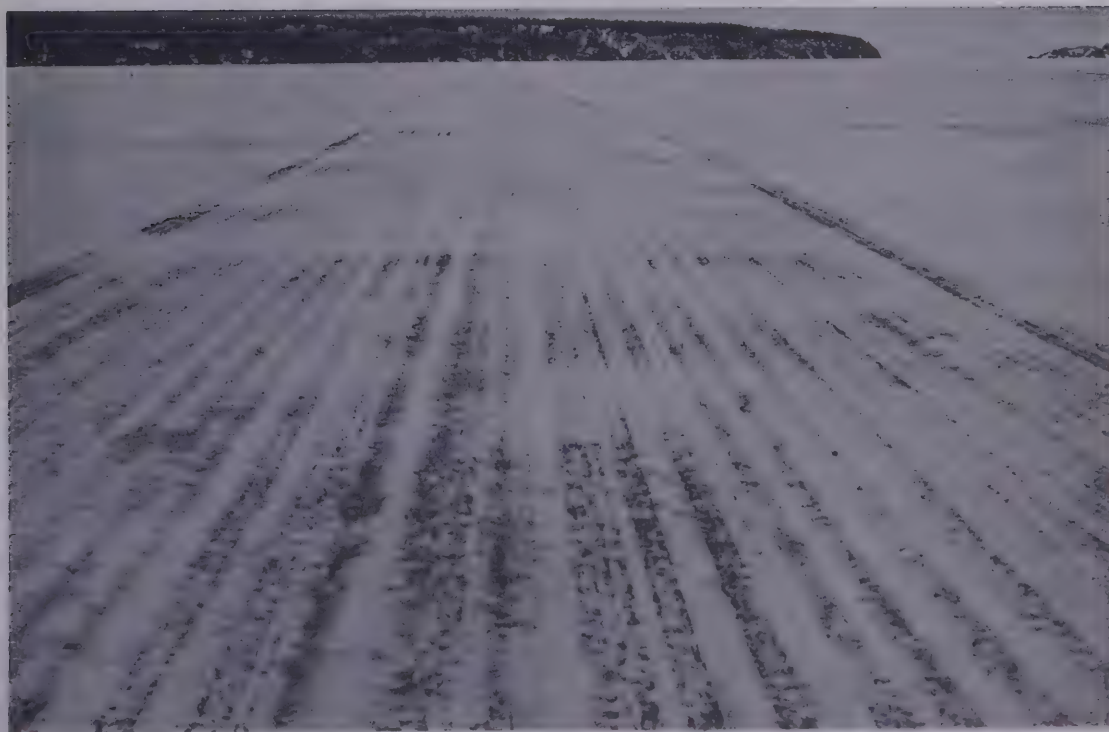
**Fig. 4 HOVERCRAFT TRACK OVER SNOW-COVERED SMOOTH ICE, AT LOW TRPM**

In high wind conditions it was quite satisfactory to run downwind at very low trpm, making good use of skirt friction. The interesting point was that this type of operation appeared to have no serious effects on skirt wear. Figure 3 shows the craft operating over typical smooth ice and fig.4 shows the track of a run over snow-covered smooth ice at low trpm. Stopping distances were not measured accurately over a speed range, but were enormously increased as compared with over-water distances; a half pirouette after reducing speed to about 20 knots, was the normal stopping technique.

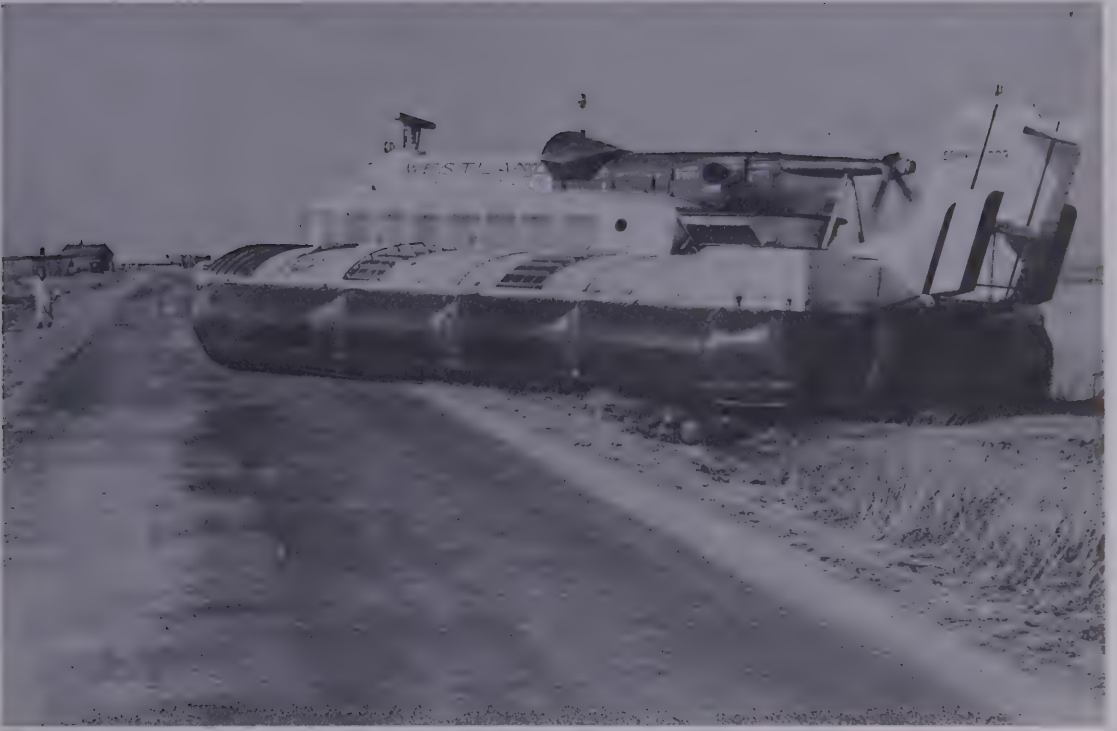
**Fig. 7 OVERLAND OPERATION AT SKANOR**

There appeared to be considerable interest in the ability of the SR.N6 to operate over land as well as water so several short passages were made over small rough areas of Northern Saltholm and later over fields, marshes and a golf course at Skanor. At this latter village an embankment carrying a roadway separated the northern saltings and estuary from a large southern area. A photograph of the craft crossing this road is given in fig.7.

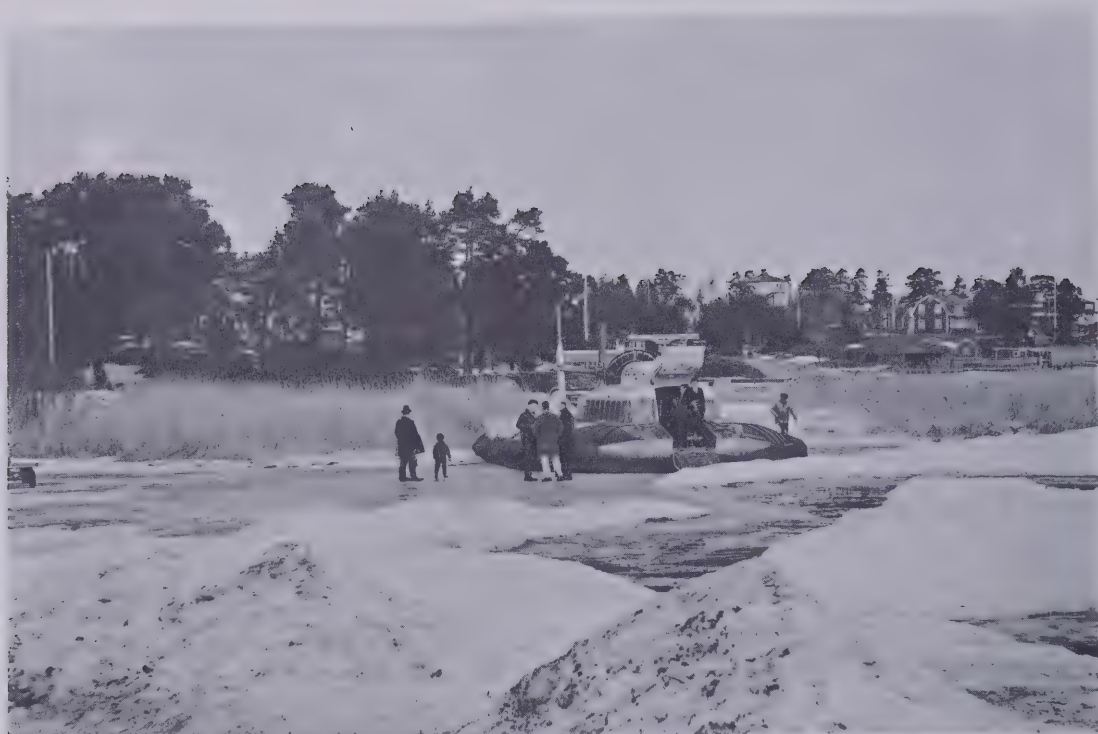
**Fig. 9 REFUELLING STOP AT ARKESUND**

(c) Arkesund, drove straight up on to snow and grass for refuelling, see fig.9.

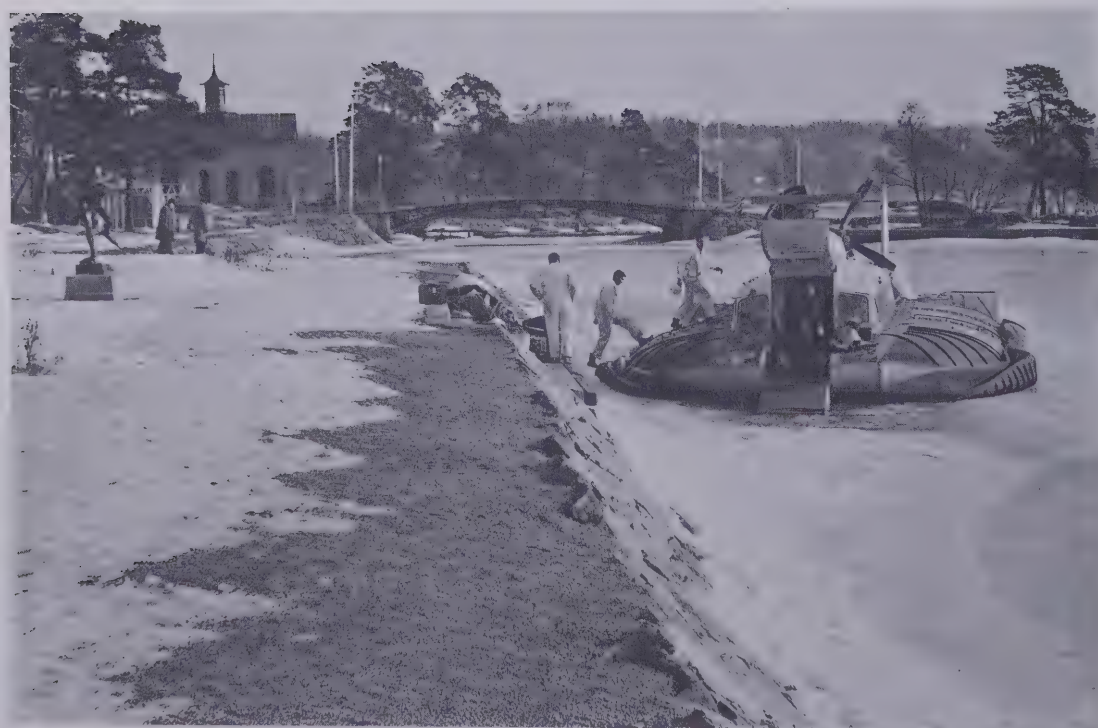
**Fig. 10 THE BASE AT SALTSJOBADEN**

(b) Really a sightseeing pleasure trip on a beautiful sunny afternoon, through one of the finest archipelagoes in the world. Nobody else was moving over or through the ice among these islands. The base at Saltsjobaden is shown in fig.10.

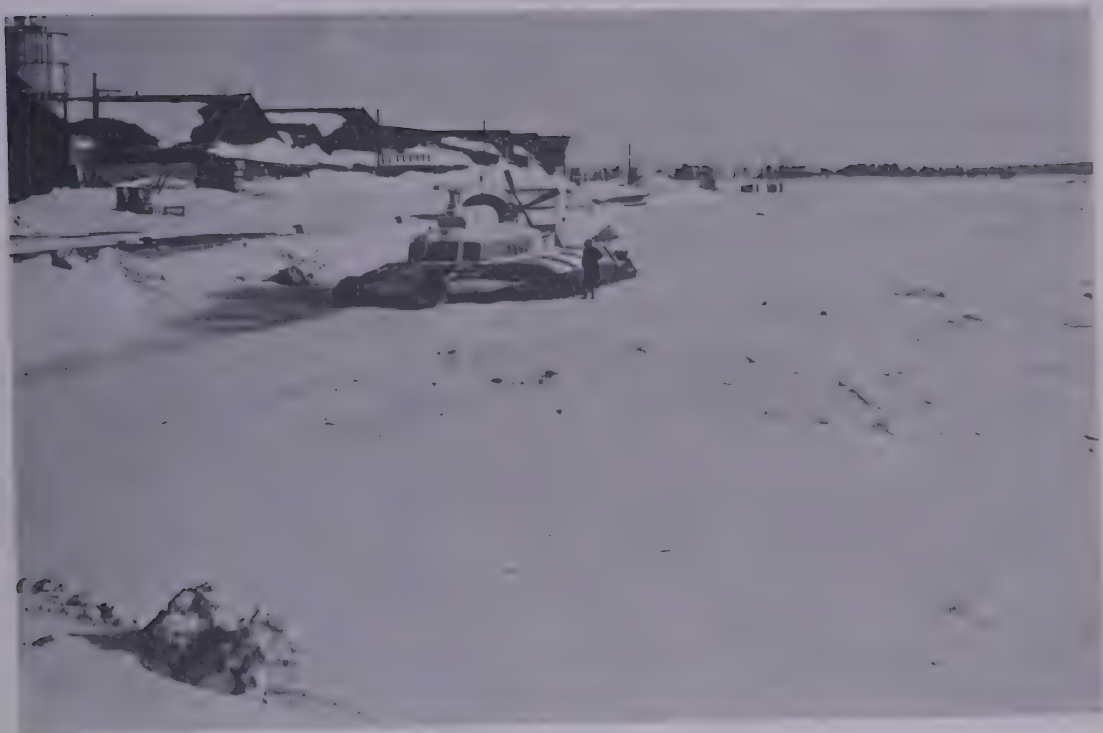
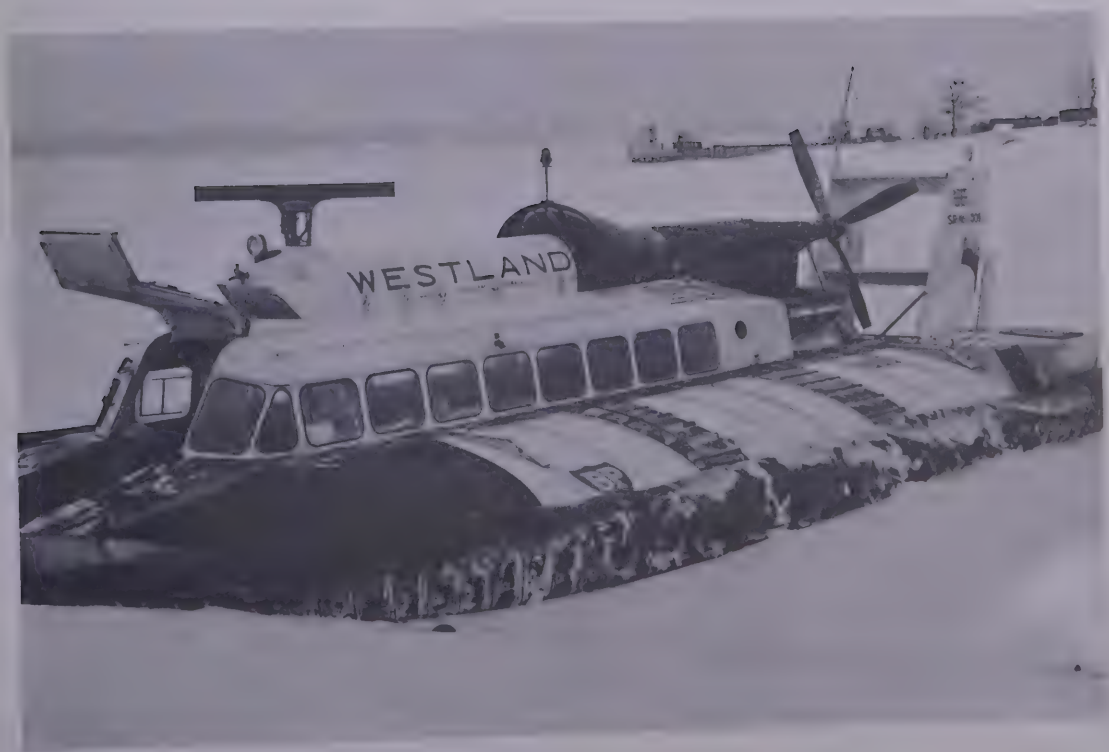
Fig. 11 & 12 THE CRAFT AT GAYLE

This was excellent navigation and piloting by the flight crew. Pictures of the craft at the Gavle base are given in fig.11 and 12.

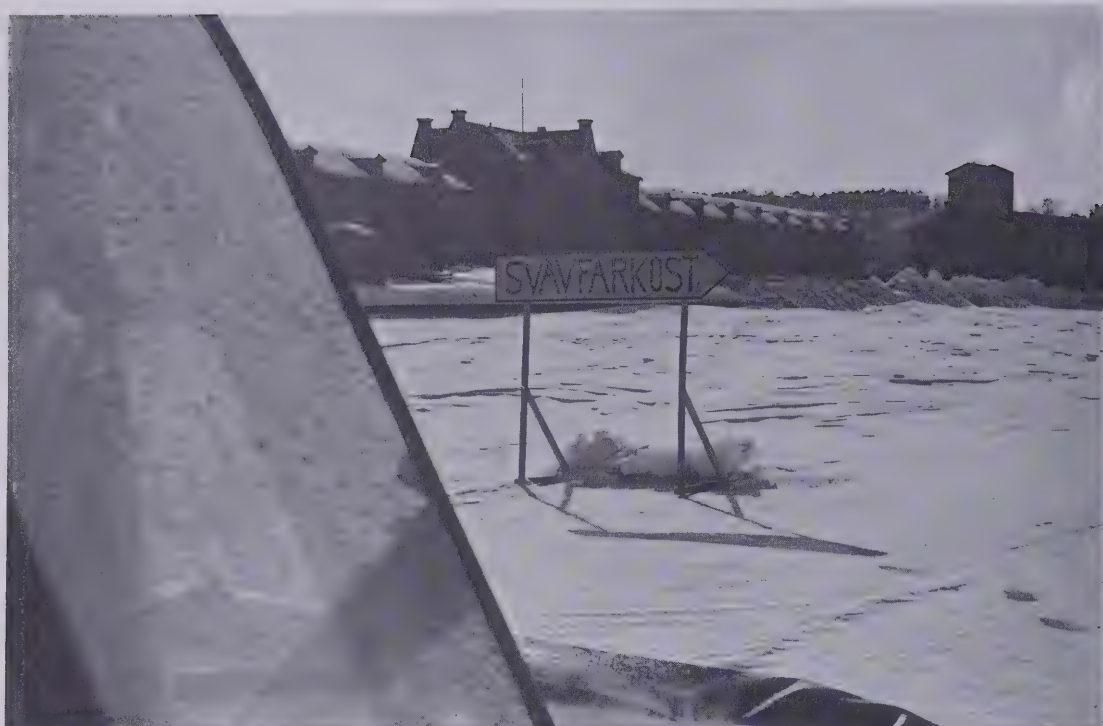
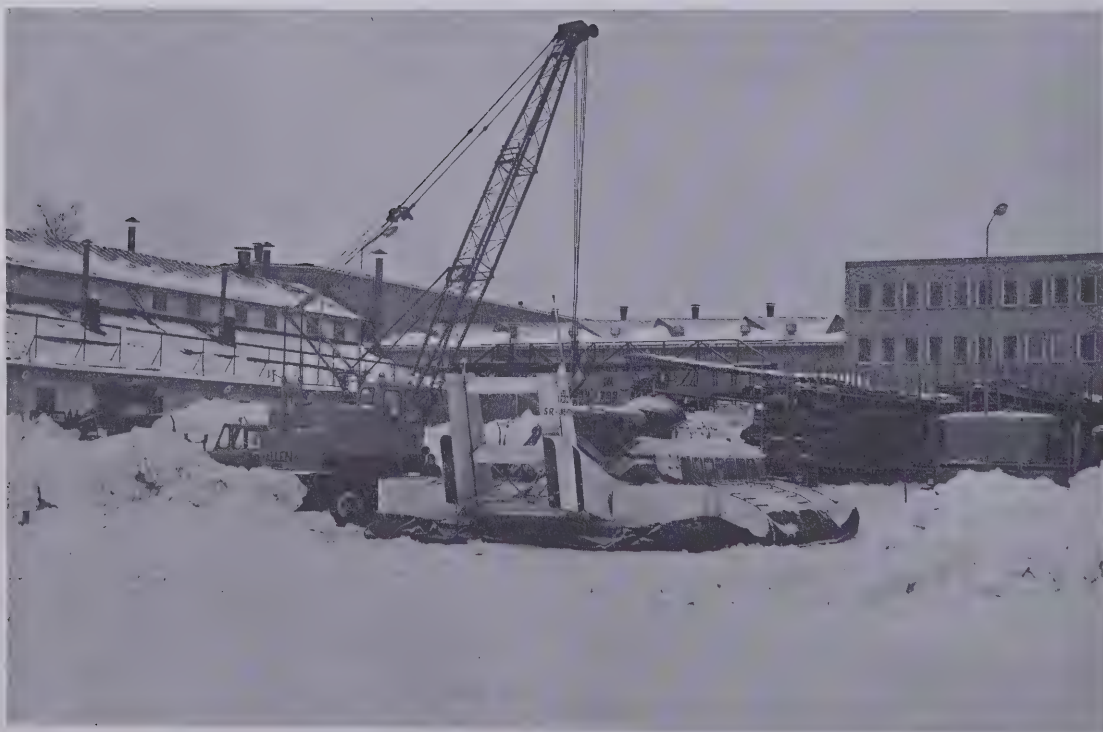
Fig. 13 & 14 THE BASE AT SODERHAMN

(c) The welcome to the newly prepared hover terminal at Soderhamn Verkstader AB was most enthusiastic. Everything asked for had been provided. Photographs of the base at Soderhamn are shown in figs. 13 and 14.

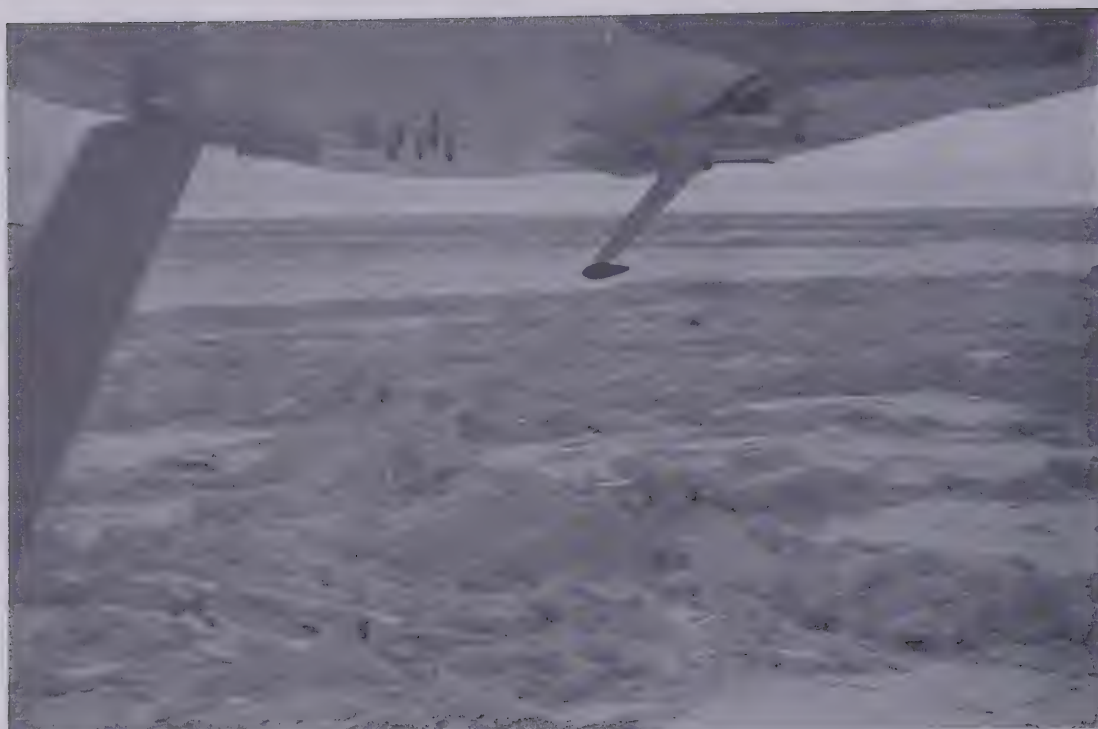
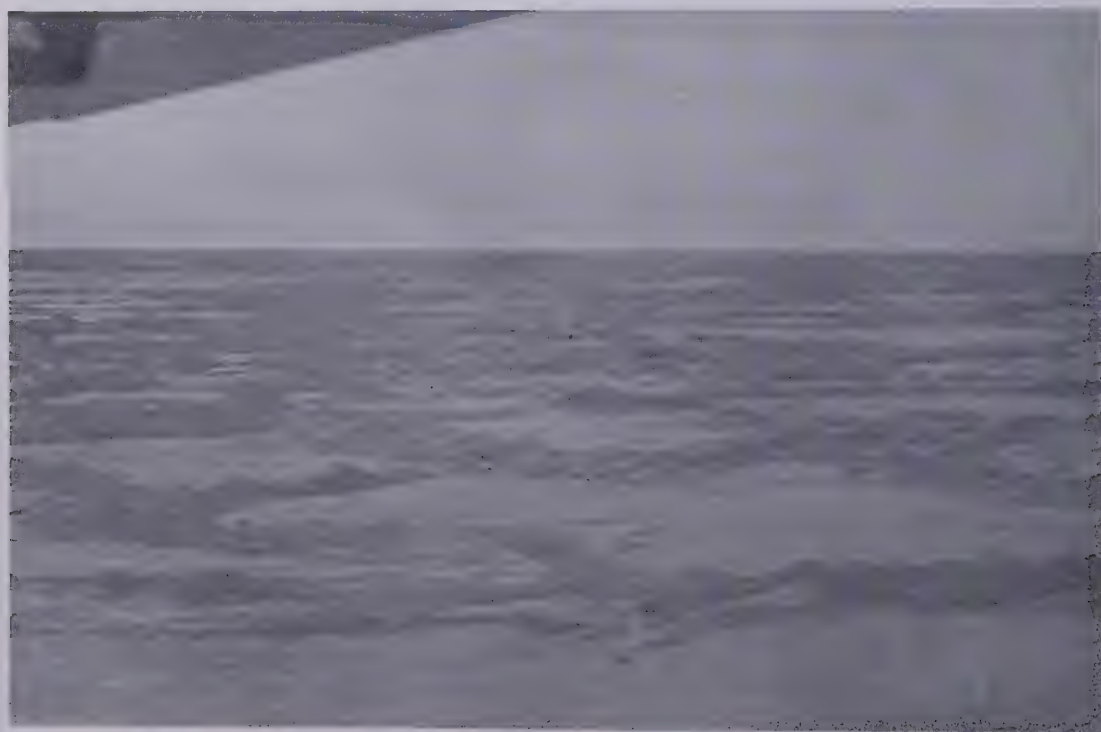
**Fig. 16 & 17 THE ICE BARRIER EAST OF SODERHAMN**

From the foregoing considerations it was concluded that none of the operation over water in Sweden had been at a low enough temperature to cause ice build-up on the craft. Whenever SR.N6 had been out in really low temperatures free water was not to be found. An aerial reconnaissance to the north and east of Soderhamn showed that there was no real possibility of getting to water in that direction, since an enormous ice barrier often 10 ft. to 30 ft. high ran more or less parallel with the coast about 7 miles to eastwards, see figs.16 and 17. Schemes were prepared to fit simple trial installations of de-icing systems as discussed below and it was arranged to blow up the ice locally when these were ready.
